**PRINTING DURABILITY TESTING OF
CHINESE CONTINUOUS INK SUPPLY
SYSTEMS
FOR INK JET PRINTERS
SUMMARY REPORT (EXCERPTS)**

This report provides excerpts of part of the "PRINTING DURABILITY TESTING OF CHINESE CONTINUOUS INK SUPPLY SYSTEMS FOR CANON INK JET PRINTERS, SUMMARY REPORT" prepared by Allion Japan Inc.

This time, we report on a printing quality comparison test between genuine ink cartridges and continuous ink supply systems actually sold in the Chinese market.

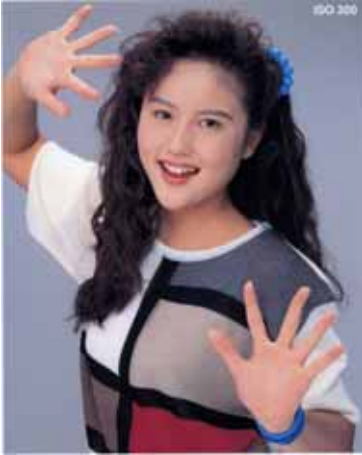
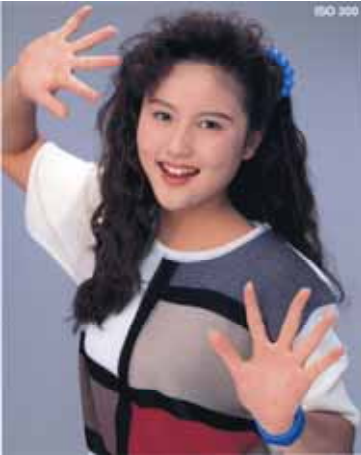
Canon genuine Initial print	Canon genuine After 1000 prints

<p>No change in color is evident compared to the initial print.</p>	
Company A Initial print	Company A After 1000 prints

When the initial print and prints after the 1000th print using CISS were visually compared, it was confirmed that changes in color occurred in the latter. This problem was confirmed for Company A, Company B and Company C. Although the degree of these color changes varied depending on the CISS manufacturer, the changes were distinctly visible. When printing was done using genuine ink, no changes in color were visible even after 1000 prints. The above results showed that, when CISS is used continuously, there is a possibility that color will change from the original prints when the system was adopted.

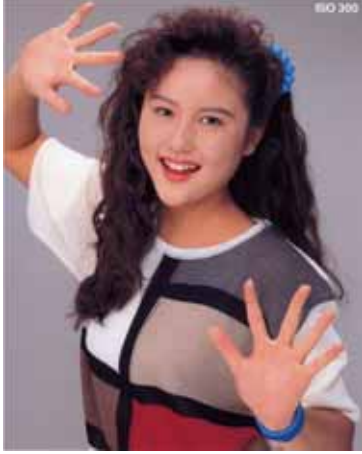
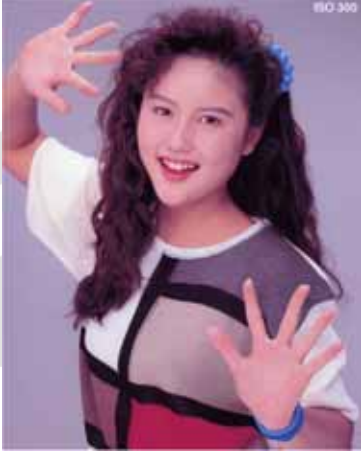
<p>Print is reddish compared to the initial print.</p>

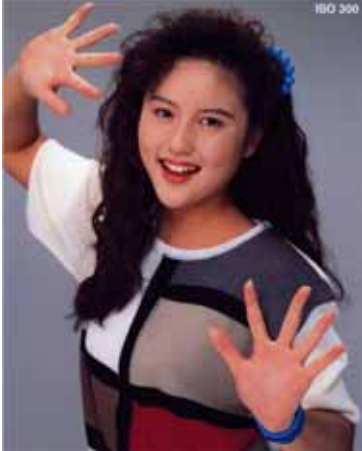
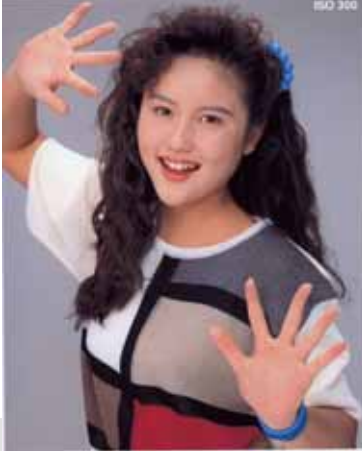
Company B Initial print	Company B After 1000 prints

<p>Colors are faded compared to initial print.</p>	
Company C Initial print	Company C After 1000 prints

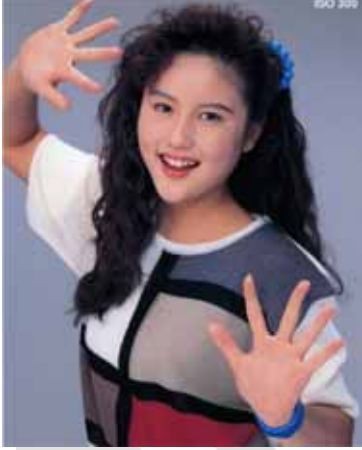
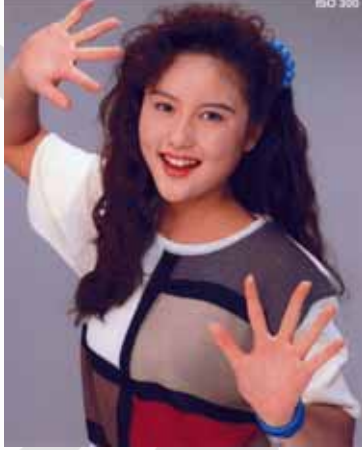
<p>Print is reddish compared to the initial print.</p>

- Printer used: PIXMA iP4500, Driver version: Ver. 2.11 • Paper used: Canon GL-101 A4 (Canon photo paper, glossy gold)
- Image used: SCID image N1A.tif, For printing N1A.tif was converted to RGB data and then used.
- Printing settings Paper setting=Photo Paper Glossy II, Printing quality=Normal, Color/Density: Auto • Page layout: Normal-size Printing

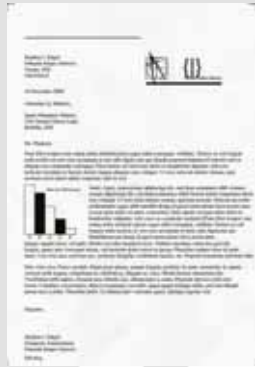
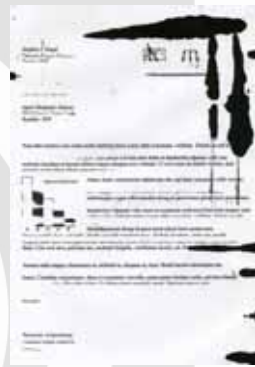
Canon genuine	Company A	Company B

<Cases of ink leakage during text printing>

No leakage evident	Leakage at a few points	Considerable leakage

- Printer used: PIXMA iP4500, Driver version: Ver. 2.11 • Paper used: Canon SW-101A4 (Canon ordinary paper, White)
- Image used: ISO/IEC 24712 data, Page 1 – Business Letter 0.1.pdf
- Printing settings: Paper setting=Plain Paper, Printing quality=Normal, Color/Density: Auto • Page layout: Normal-size Printing

When the amount of ink in a CISS system ran low (visually 5 mm or less), refill ink was supplied to the CISS system according to the manual which came with the CISS and similar precautions etc. Then, when testing was resumed, ink leaked from the print head and fouled the prints. It is thought that ink leakage occurred during printing because ink moved from the external tank to the print head side when ink filling was done. This problem occurred with CISS from all companies, and ink leakage did not occur in the Canon genuine case.

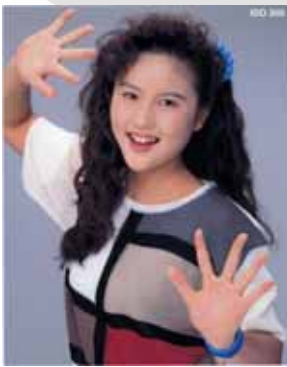
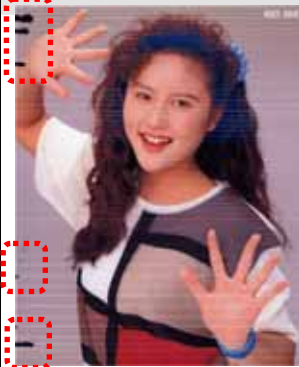
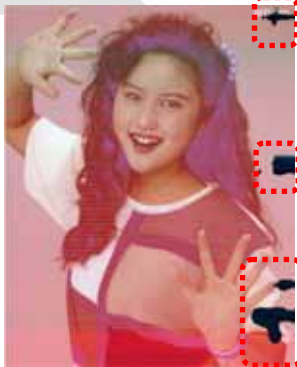
Canon genuine	Company A	Company C

<Cases of ink leakage during image printing>

No leakage evident	Leakage at a few points	Considerable leakage
